# Manhole Inspection Summary

Manhole # S29EE1018MH

Insp Date: **4/2/07 10:22 AM**

**Location** Address: **3730 TUDO ARMS AVE**

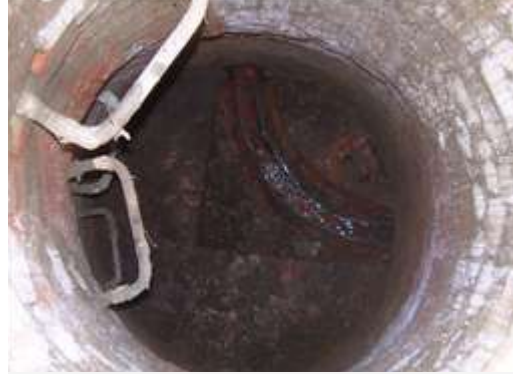
Top View

**Bench** ☒ Exists Material: **Brick** ☐ Parged ☒ **Debris** (not Condition related)

**Surcharge** ☒ **Evidence Of Surcharge** Depth: **2** (ft.) ☐ Active Surcharge Present

Evidence of surcharge - Bench debris.

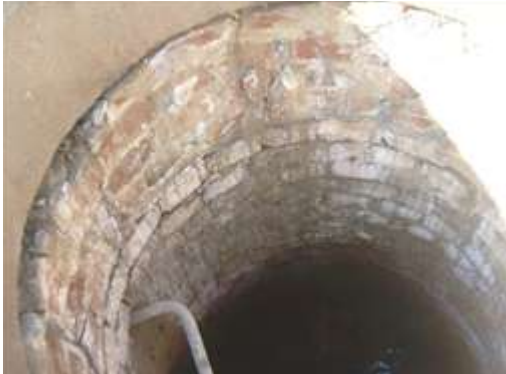
Defect

**Frame** Offset: **0** (in.) Condition: ☐ Sound ☐ Cracked ☒ **Leaks**

Condition: ☐ Sound ☐ Cracked ☐ Root Intrusion ☐ Loose Brick ☒ **Deteriorated**

Infiltration: ☐ None ☒ **Joint** ☐ Cracks ☒ **Mortar** ☐ Roots ☐ Wall

Infiltration: ☐ None ☐ Joint ☐ Cracks ☒ **Mortar** ☐ Roots ☐ Wall

Frame leaks. Adjustment and Corbel deterioration and infiltration.

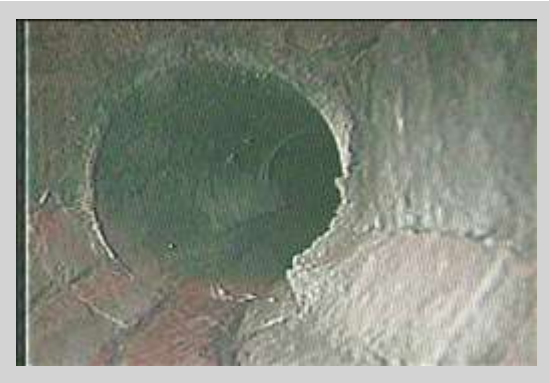
### 8 in. Circular Gravity Sewer Pipe Out @ 12 O'Clock

Infiltration: **Evidence** Pipe Seal Cond: **Cracked**
